Department of Toxic Substances Control

March 7, 2006

The Department of Toxic Substances Control (DTSC) received the Current Conditions Summary Report for Lot 3, Campus Bay, 1200 South 47th Street Richmond, California (July 29, 2005), and the Lot 3 Field Sampling and Analysis Plan, Campus Bay Site, Former Zeneca, Inc., Richmond Facility, Richmond, California (November 2, 2005). Both reports were prepared by LFR Levine-Fricke on behalf of Cherokee Simeon Venture I, LLC, Zeneca, Inc., and Bayer CropScience, Inc., collectively known as the Respondents to DTSC's Site Investigation Order (Docket No. 04/05-006). The Current Conditions Summary Report for Lot 3 provides a description of the Zeneca/Former Stauffer Chemical Site, summary of previous site investigations, summary of previous conceptual site models and remedial actions, a description of current site conditions, and an evaluation of data gaps. The field sampling plan describes the sampling methods and sample locations to fill the data gaps identified in the current conditions reports.

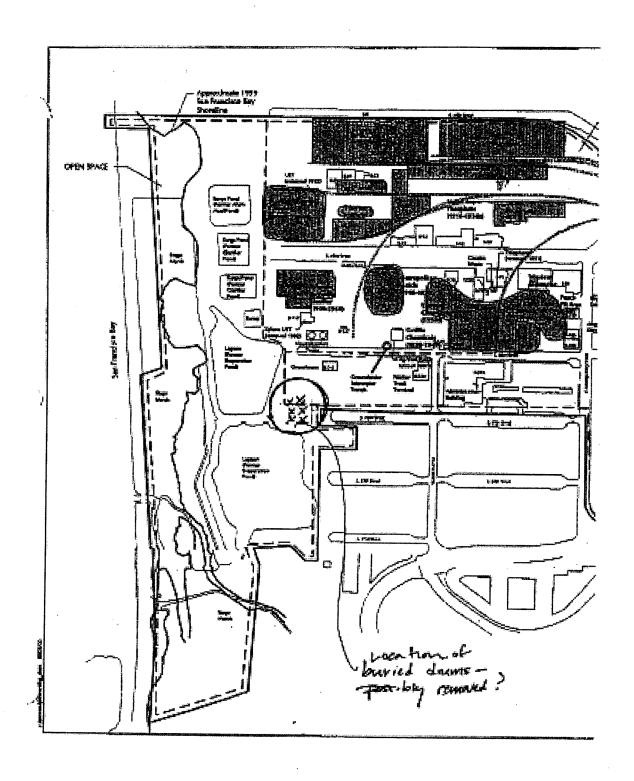
- 6. DTSC has received information that drums were buried and may have been removed from within Lot 3 (see attached figure). Please submit information associated with any construction work that may have occurred within this area (e.g., storm lines, etc.) A magnetometer survey of this area should also be conducted to determine whether there are any buried metal objects in this location.
